HYDRAULIC FRACTURING

BAKKEN SAFETY TOUR 2016
AUGUST 31 - SEPTEMBER 2

Area Director, Bismarck Area Office, Region VIII
Occupational Safety and Health Administration
UNITED STATES

Incidents and Lessons Learned

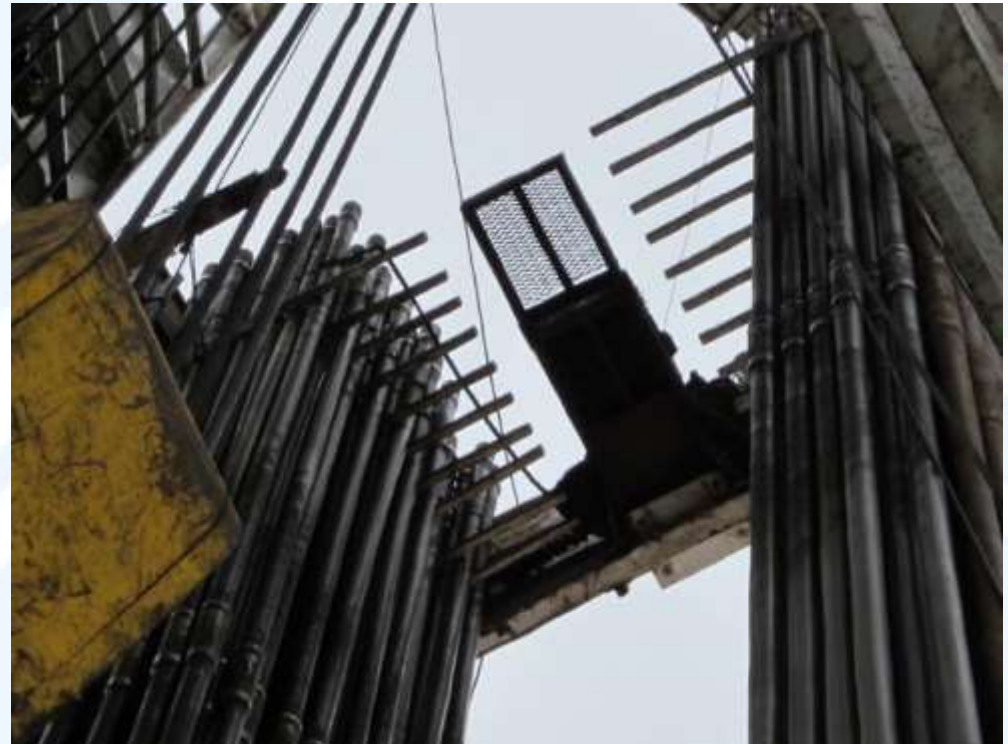
- Employee was working on the derrick board—stringing pipe—when he attempted to remove a screen from one of the sections.
- Moved to “monkey” board to get better position.
- Crossed over another employee.
- Crew was still tripping pipe.

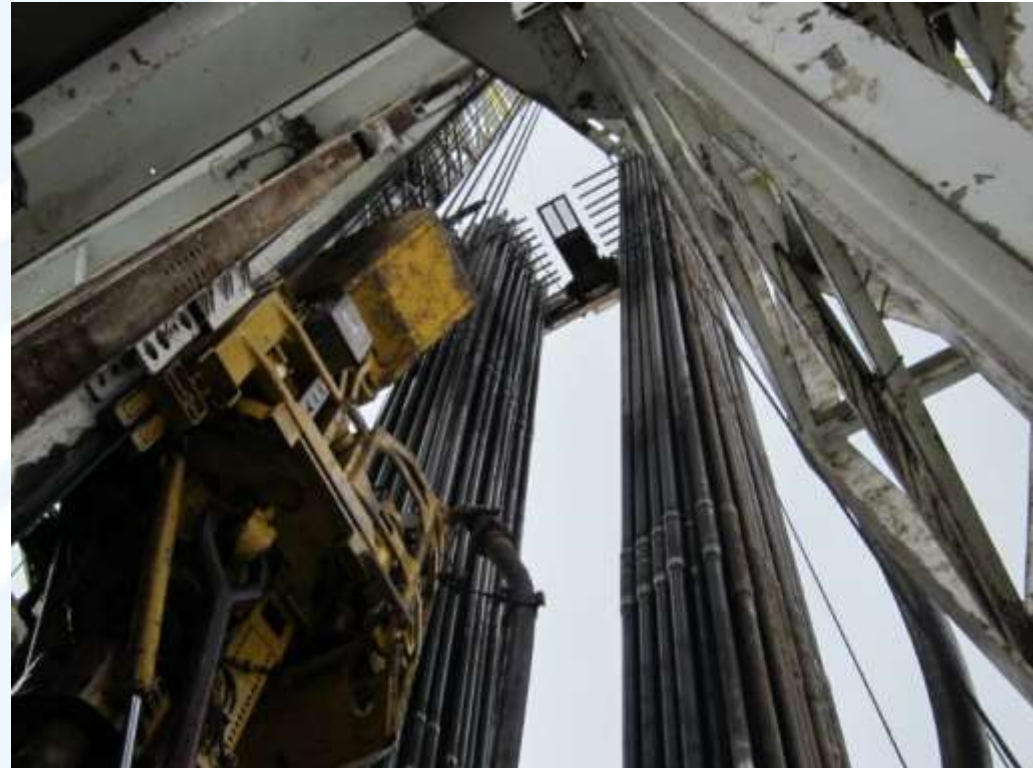
- Traveling block and top drive descended.
- Caught lanyard.
- Pulled employee off the platform.
- Snapped harness, employee fell approximately 75 feet to his death.

- *Critical Factors & Prevention*
- Fall protection systems, to include their anchoring mechanisms, should be designed to ensure their pathways remain clear of the traveling block and all moving mechanical parts or systems.
- Whenever an employee is climbing or descending the derrick ladder, keep the traveling block (and all moving mechanical parts) in a stationary position. This will prevent any “catch” onto the fall protection system line.

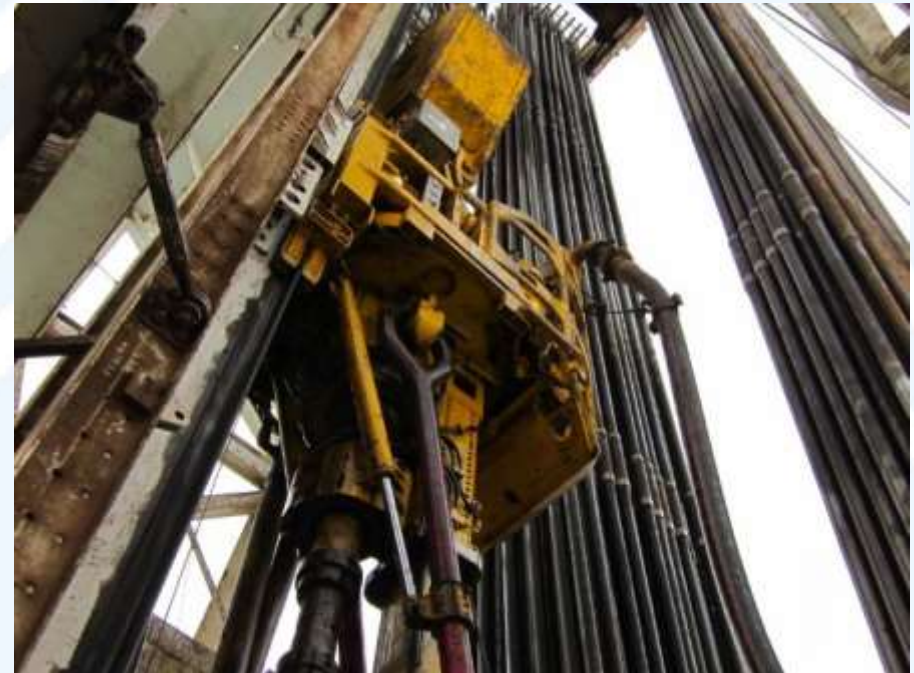
Case Study 2

- Two employees engaged in boiler maintenance on a drilling rig.
- Noticed boiler pressure and temperature were low—even though boiler was on high burn.
- Were trained to use an improper procedure—quick opening and closing of valves.
- “Water Hammering.”
- Furnace exploded, killing one and severely burning the other.

- *Critical Factors & Prevention*
- The boiler manufacturer's procedures for shut-down must be followed at all times. Using the quick opening valves to alternate the blow down is highly dangerous.
- Employees engaged in boiler maintenance and servicing operations must receive adequate training specific to their assigned tasks.

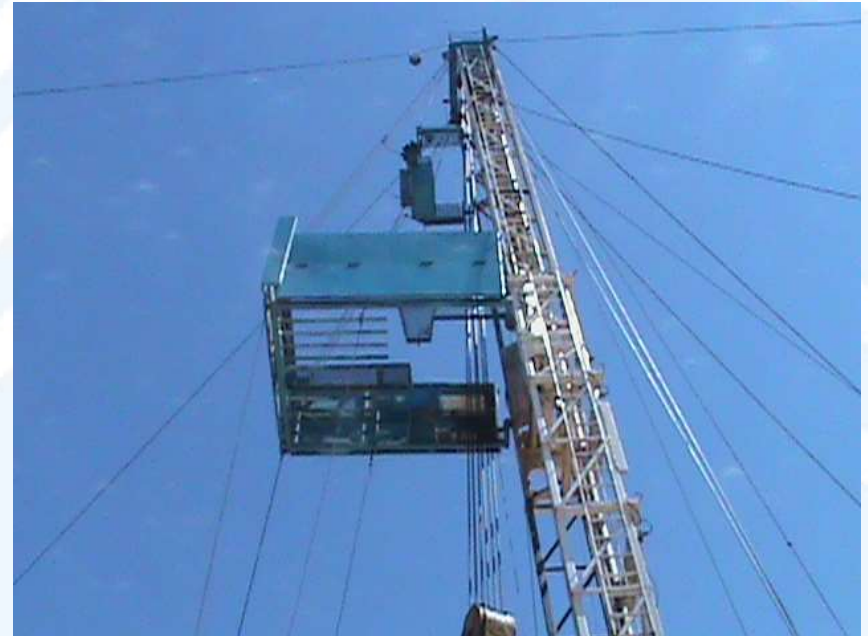
- Well servicing operation.
- Four person crew.
- Derrick man climbed up to the basket.
- Crew at bottom opened the pressure release valve—bleeding off natural gas.
- Derrick man working above the valve fell to his death.
- He was wearing a harness, but not secured to an anchoring system.

- *Critical Factors & Prevention*
- Ensuring fall protection systems, to include their anchoring mechanisms, are utilized at all times where required. Wearing a harness without tying off is the same as not wearing a harness at all.
- Employees with exposure to fall hazards to receive training specific to their work operation and potential workplace hazards.
- Use of four-gas monitors (CO, O₂, H₂S, LEL).

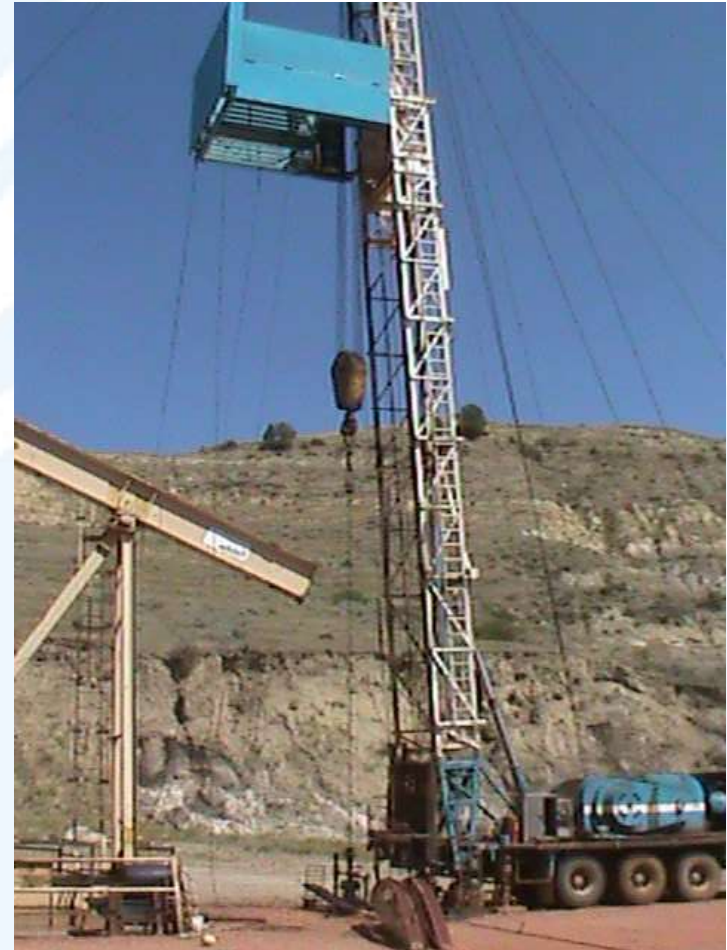
Case Study 4

- Well servicing operation.
- Preparing to begin snubbing operation.
- Well was still under pressure, free-flowing product to a separation tank.
- Uncontrolled release of pressure—blowing the top flange cover off.
- Amputation of one employee's arm—concussions to two others.

- *Critical Factors & Prevention*
- Ensuring the correct well control procedures are followed at all times. For example, making sure the pipe ram is closed prior to beginning snubbing operations.
- Ensuring employees engaged in oil & gas operations receive training specific to their work operations and potential workplace hazards. This is especially important for “short-service” employees and those new to the company. *Prior oilfield experience is not necessarily an indicator of one’s knowledge of safe working practices.*

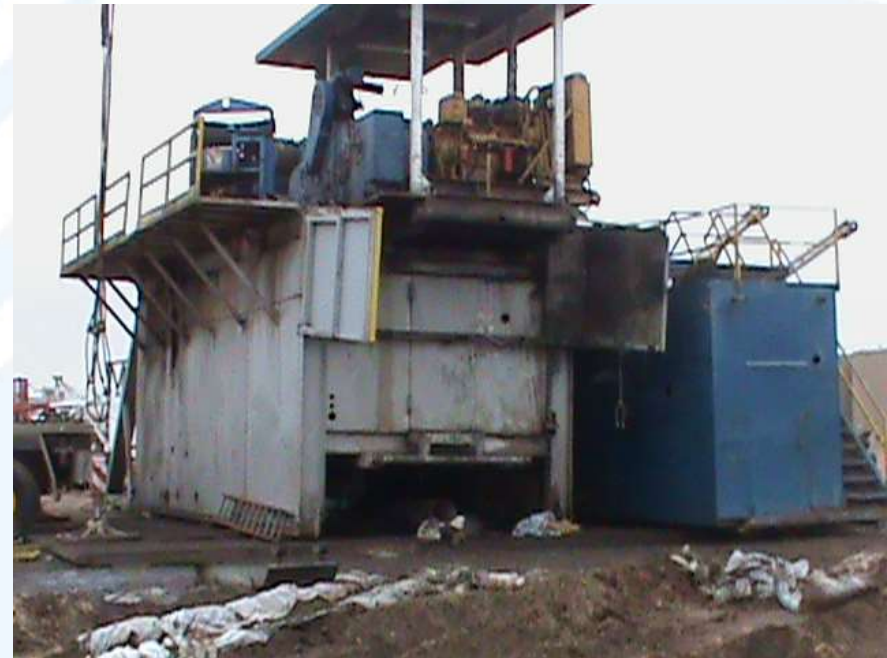
Case Study 6

- Well servicing operation.
- Installing a new pumpjack—horsehead pump.
- Removed wellpipe and in process of reinserting when well started to overflow.
- Operator attempted to activate the BOP—three times—to no avail.
- Well exploded.
- New employee, 2 days, engulfed in flames and died.
- Three other employees severely burned.
- One died, another had both legs amputated.

- *Critical Factors & Prevention*
- Ensuring employees engaged in oil & gas operations receive training specific to their work operations and potential workplace hazards.
- Ensuring the correct well control procedures are followed at all times. This includes ensuring the BOP is correctly installed.

- *Critical Factors & Prevention*
- Ensuring an auxiliary means of escape, such as a Geronimo line, is installed. (if the line was installed, the most employee would not have had to climb down towards the explosion).
- Ensuring the personal protective equipment or PPE, suitable for the work operations, is provided and utilized. This is particularly important for work operations where the nature of the hazards require the use of Flame Resistant Clothing or FRC.
